Looking towards the future: Rehabilitation of Itztal bridge railway overpass successfully completed

- Spesa and Schachtbau Nordhausen repair a railway overpass near Roedental.
- Concrete damages caused by chemical attack reactions in the pier caps
- Roughly 2,000 m of fractures tamped and grouted
- Pier caps prepared and coated over an area of 3,500 m²

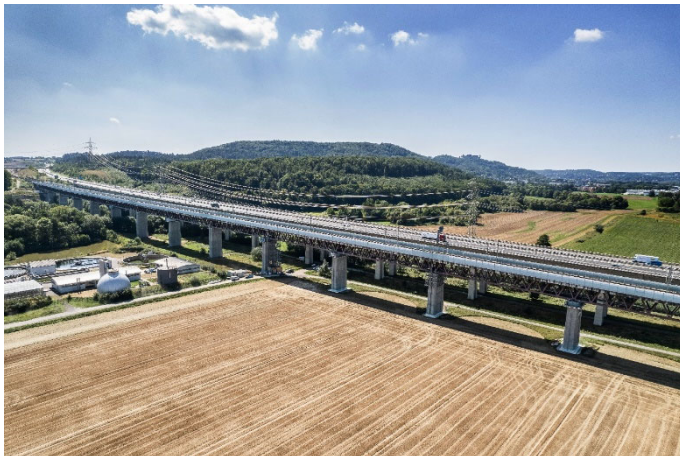
(1) The rehabilitation of 14 bridge piers and caps for the Itztal bridge railway overpass was successfully completed in June 2024.

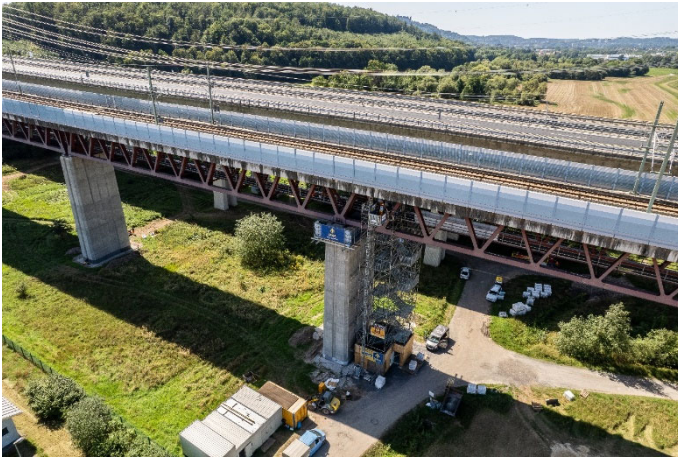
(3) Work on the pier caps was executed using suspended scaffolding.

The focus at the start of work was on the pier caps. First, the subsoil was prepared extensively over an area of 3,500 m². This was followed by tamping and grouting roughly 2,000 m of existing fractures. The final step was coating the entire processed surface of 3,500 m². The specialists on the injection platforms also installed 500 m² of sloping PCC with anchored stainless steel mats which were then sealed with a crack-bridging, walk-over surface protection system. In addition, 1,800 m of grooves were constructed for sensor technology and extensive measures were taken to protect the pier bases against penetrating moisture as well.

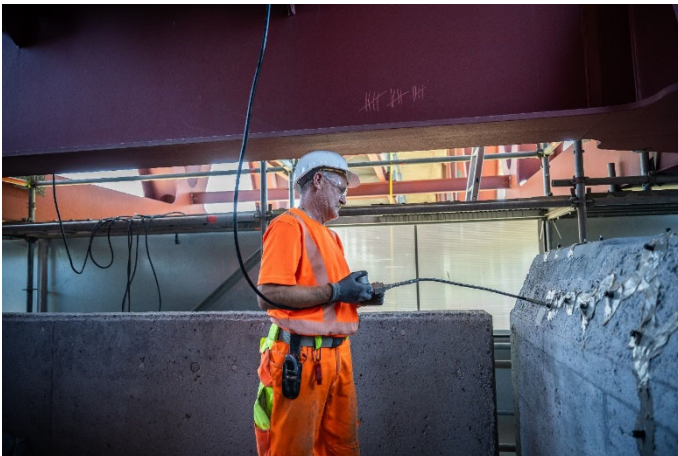
(4) In total, 2,000 m of fractures were tamped, grouted and then coated.

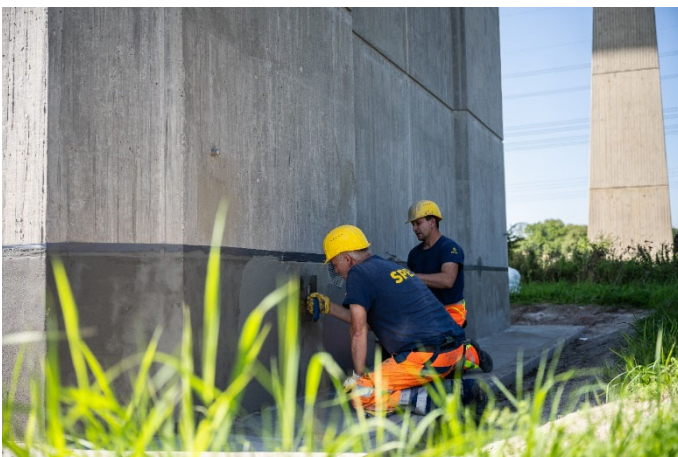
(5) To protect against penetrating moisture, the pier bases were also treated extensively.

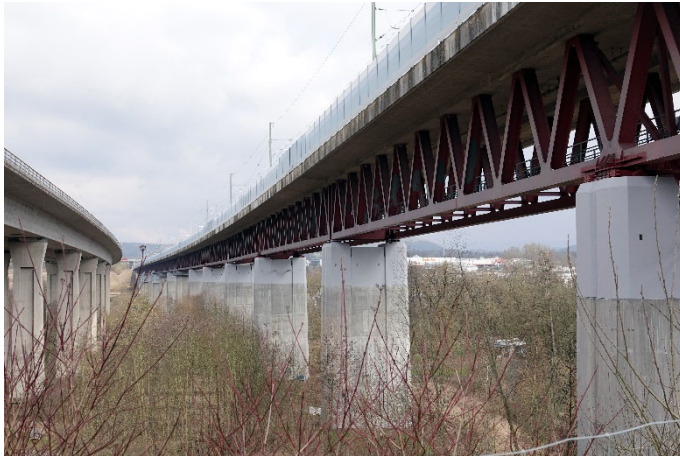
(6) The freshly renovated pier caps of the Itztal bridge railway overpass
